Manhole Inspection Summary

Manhole # S37KK_015MH

Insp Date: **3/20/07 11:30 AM**

Location Address: **1815 BARCLAY ST**

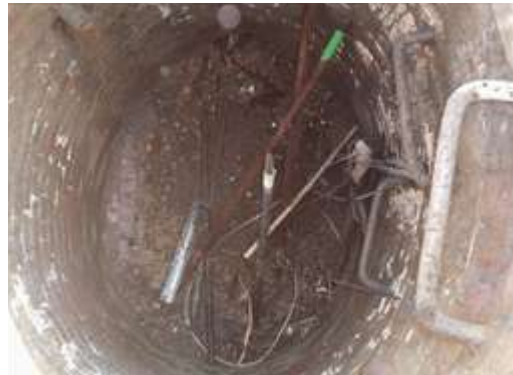
Top View

Barrel infiltration. Channel debris.

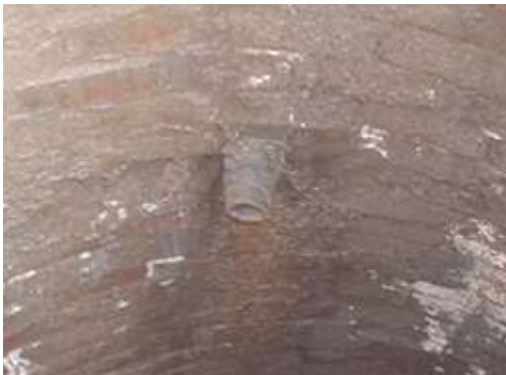
Valve coming in through Barrel

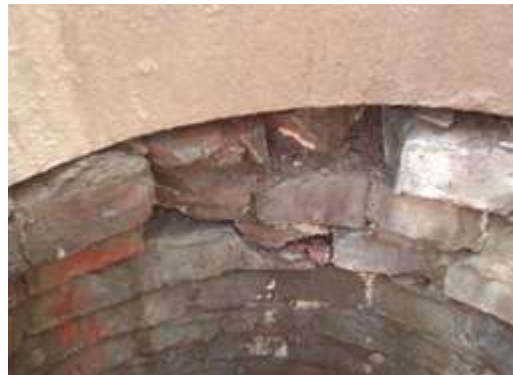
Defect

Frame leaks. Corbel deterioration and infiltration.

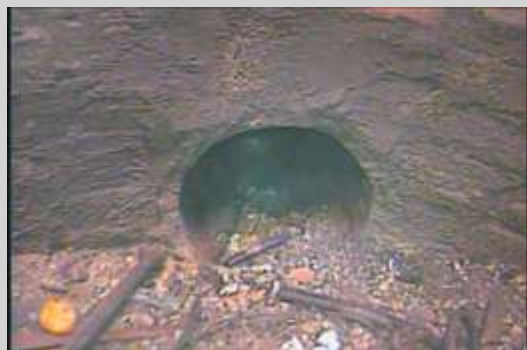
8 in. Circular Gravity Sewer

Pipe Out @ 12 O'Clock

Pipe Seal Cond: **Broken**
